INSTALLATION RESTORATION PROGRAM

CLOSURE ASSESSMENT REPORT FOR UST REMOVALS AT SITES 4 AND 5 - PETROLEUM, OILS, AND LUBRICANTS FACILITY

VIRGINIA AIR NATIONAL GUARD
192nd FIGHTER GROUP
RICHMOND INTERNATIONAL AIRPORT
SANDSTON, VIRGINIA

FINAL
NOVEMBER 1996

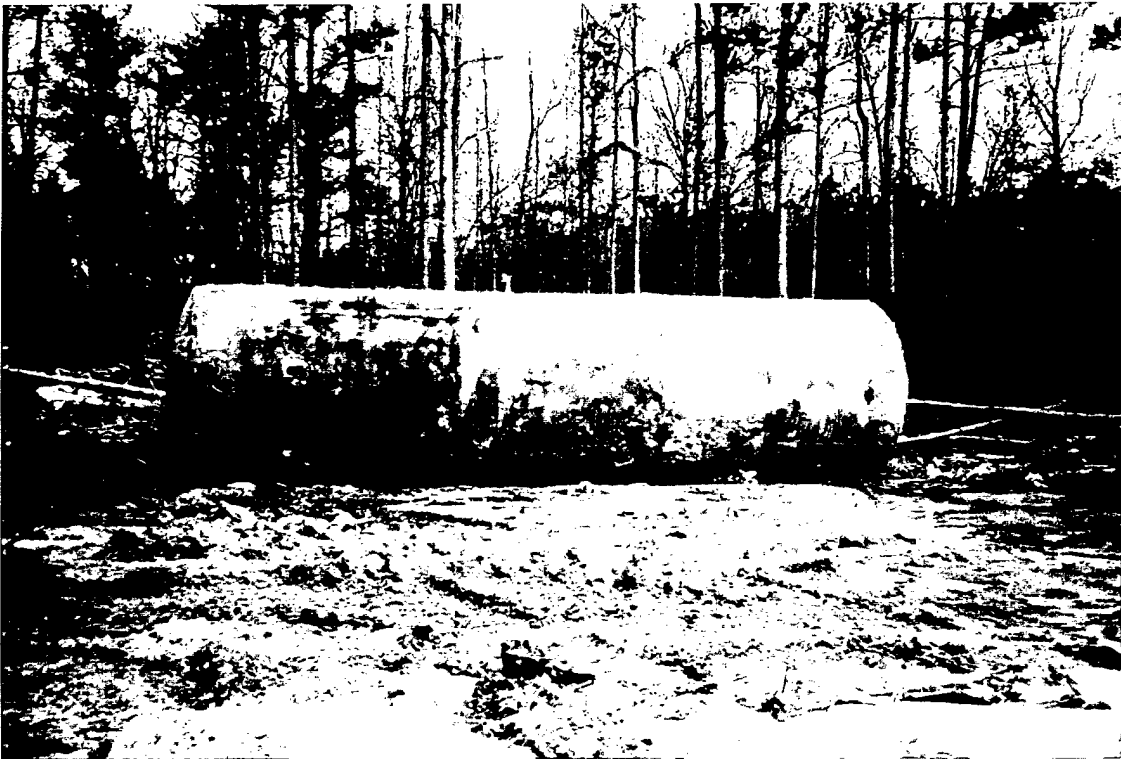
Site 5 - UST No. 12 in Temporary Storage. View to the North.
(Photo Log No. 5; Roll No. 2/Frame No. 21)

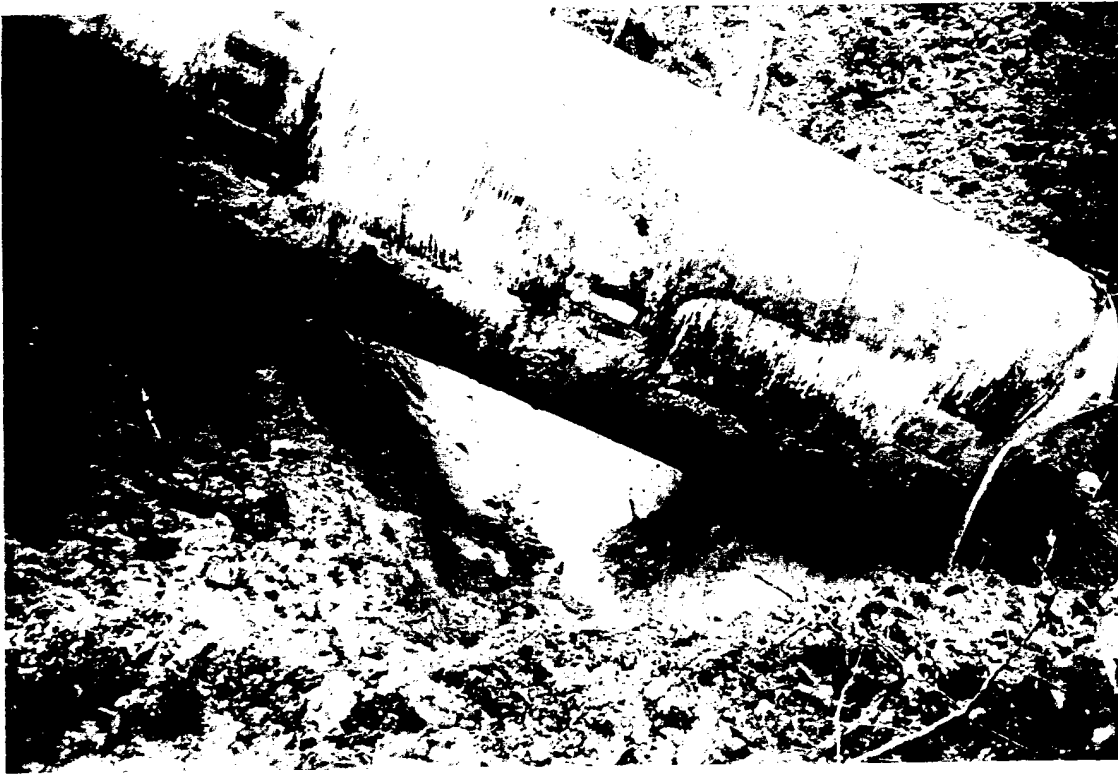
Site 5 - UST No. 11 Removal. View into the Pit.
(Photo Log No. 5; Roll No. 2/Frame No. 24)

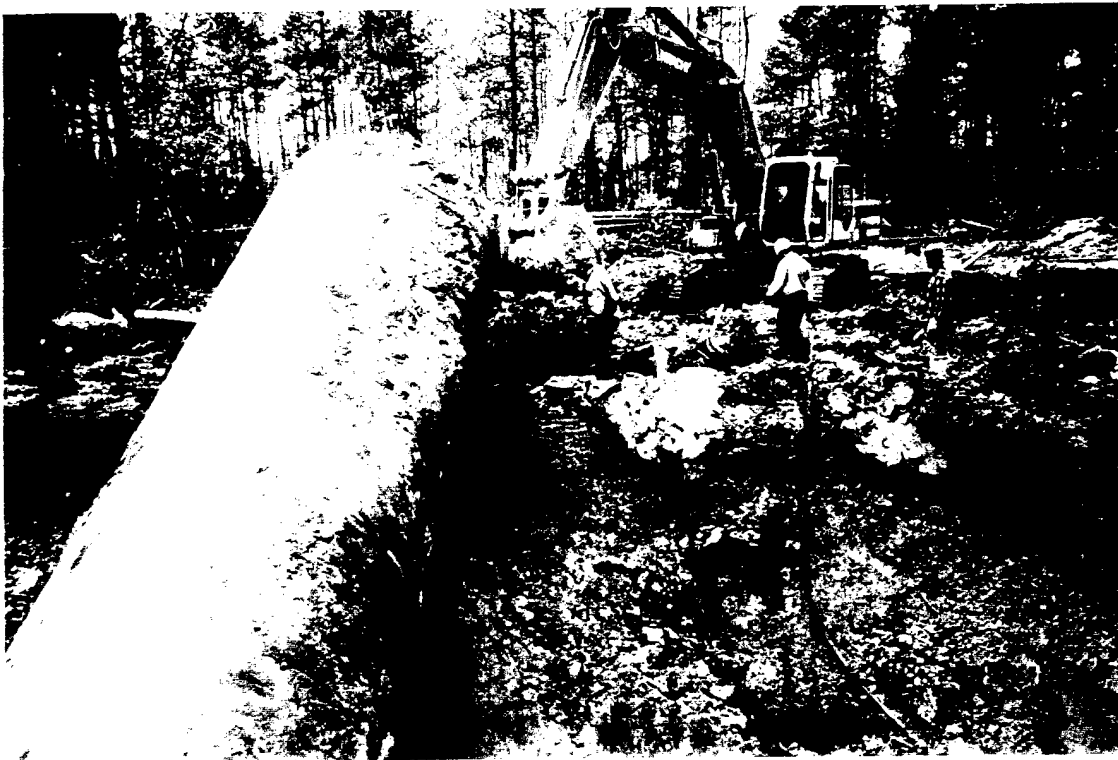
Site 5 - UST No. 11 Removal. View to the West.
(Photo Log No. 5; Roll No. 2/Frame No. 27)

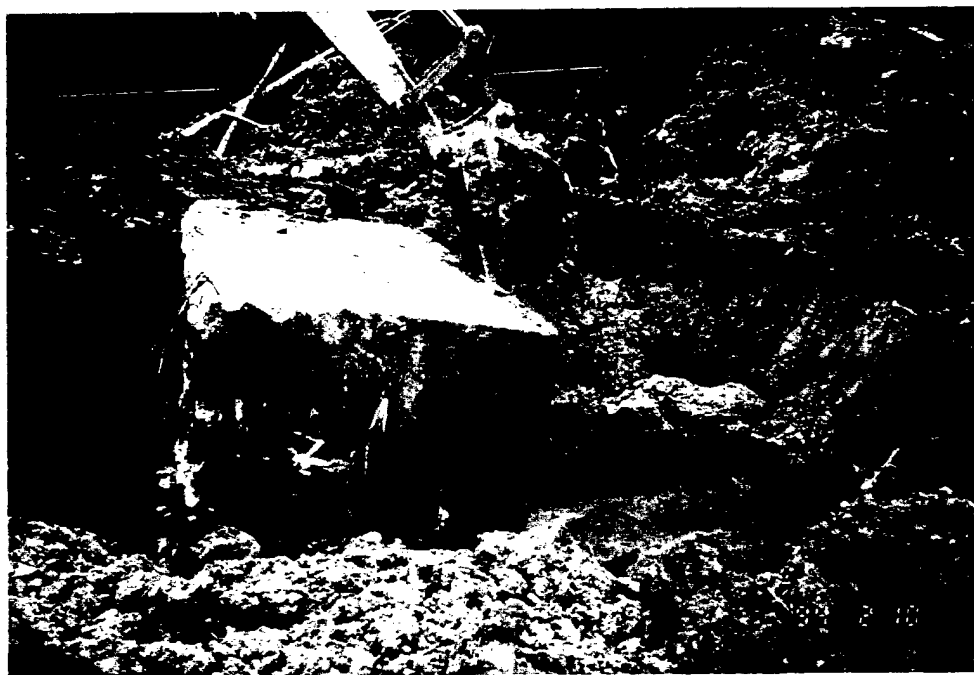
Site 5 - Valve Pit/Pressure Control Pit Removal. View to the Southeast.
(Photo Log No. 12; Roll No. 7/Frame No. 11)

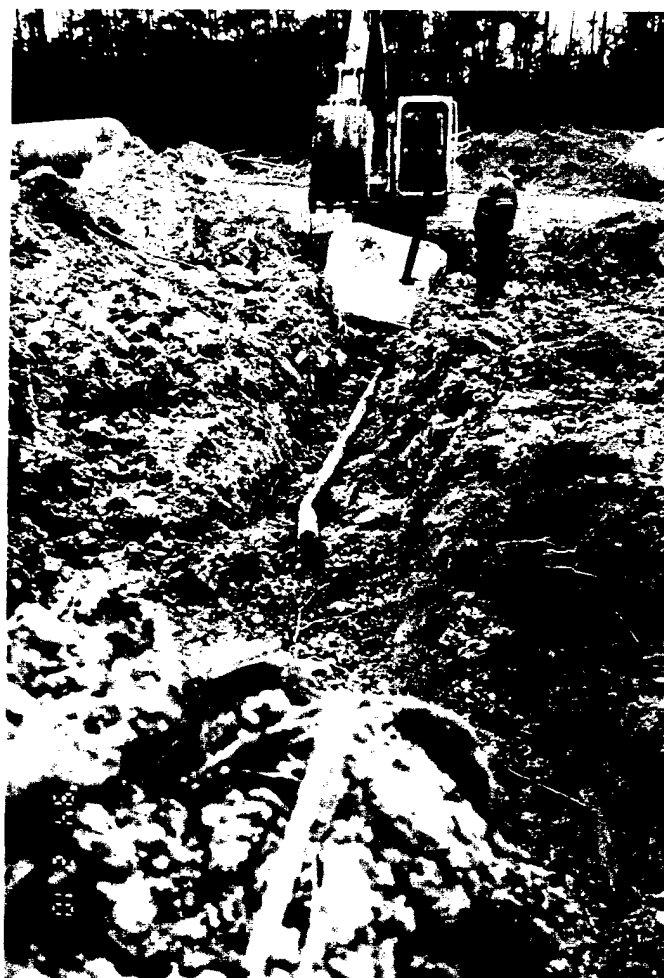
Site 5 - Pipe/Valve Pit Removal. View to the Northwest
(Photo Log No. 12; Roll No. 7/Frame No. 7)

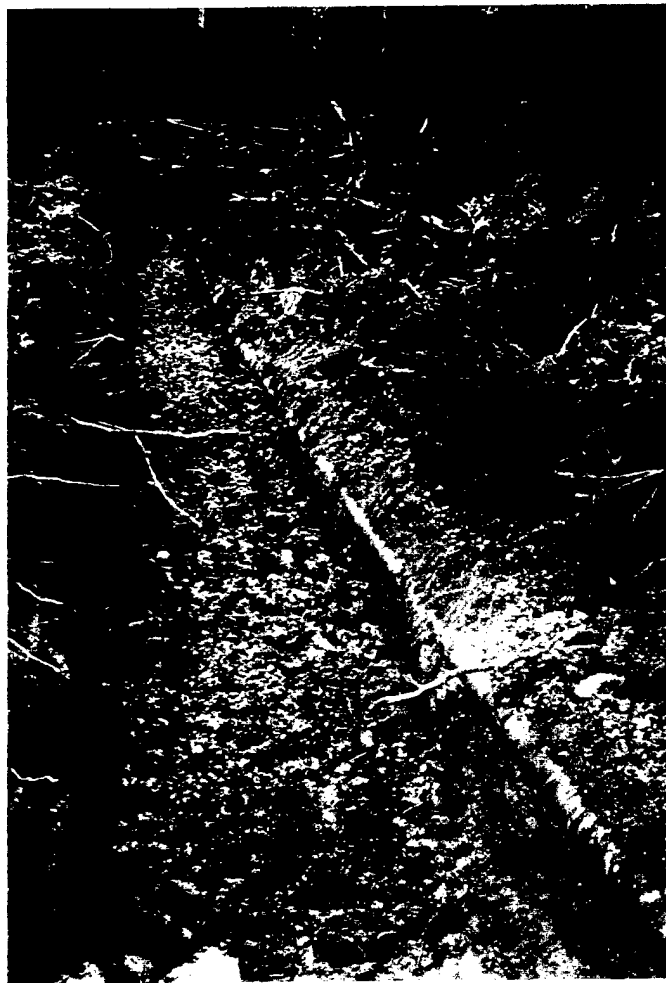
Site 5 - Principal 6 inch
AVGAS Pipeline Removal.
View to the Northwest.
(Photo Log No. 2;
Roll No. 1/Frame No. 27)

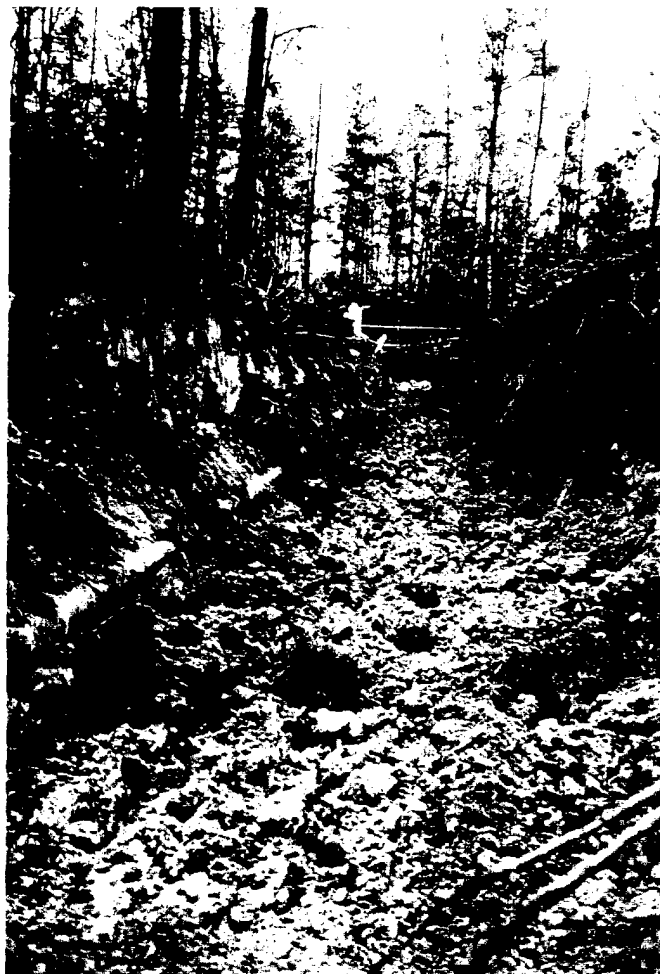
Site 5 - Principal 6 inch
AVGAS Pipeline Removal.
View to the Southeast.
(Photo Log No. 2;
Roll No. 1/Frame No. 28)

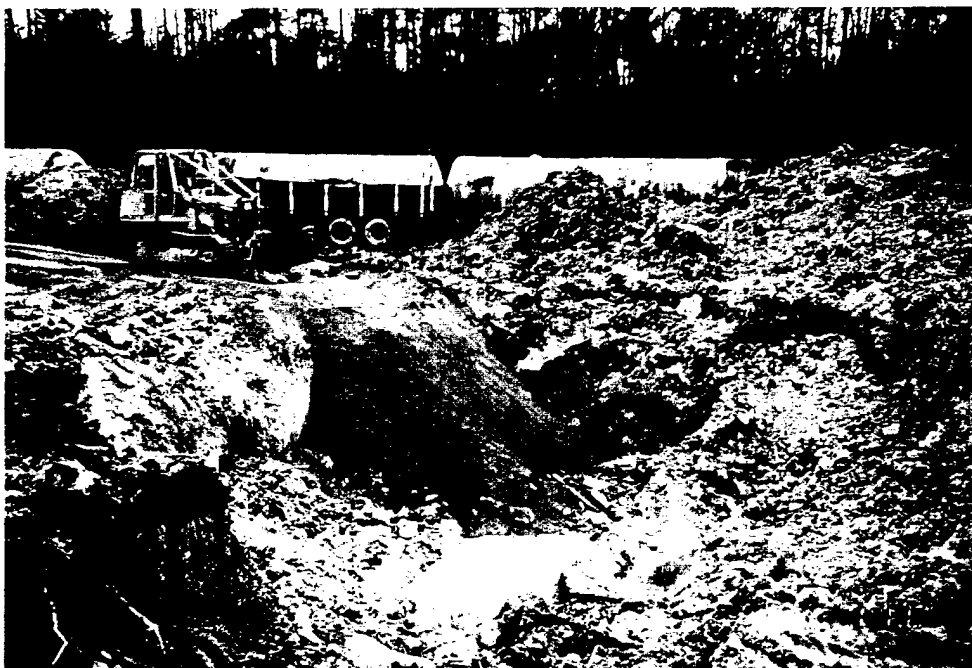
Site 5 - Backfill Operations, UST Nos. 7/8. View to the Northwest.
(Photo Log No. 7; Roll No. 4/Frame No. 4)

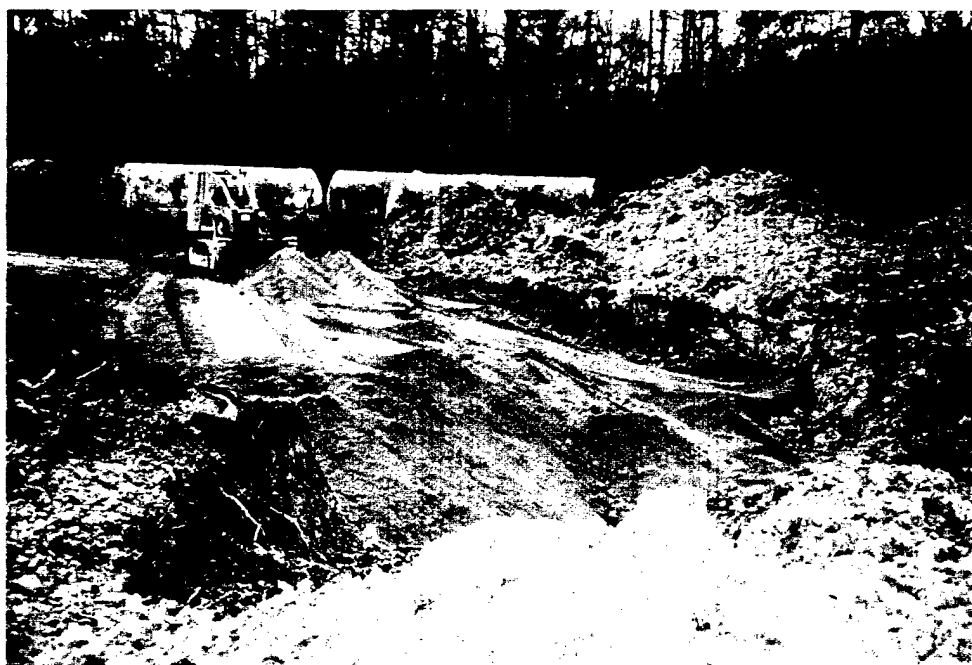
Site 5 - Backfill Operations, UST Nos. 7/8. View to the Northwest.
(Photo Log No. 7; Roll No. 4/Frame No. 11)
